In re Application of:	Carpenter <i>et al.</i>	Confirmation No.:	5405
Serial No.:	09/769,670	Group Art Unit:	2831
Filed:	01/25/2001	Examiner:	Patel, D.
For:	Grounding System for Floating Roofs in Flammable Storage Tanks	Attorney Docket:	RM26ii

**REVISED DECLARATION OF NON-OBVIOUSNESS
PURSUANT TO 37 CFR § 1.132**

RETRACTABLE GROUNDING ASSEMBLY™ (RGA™)

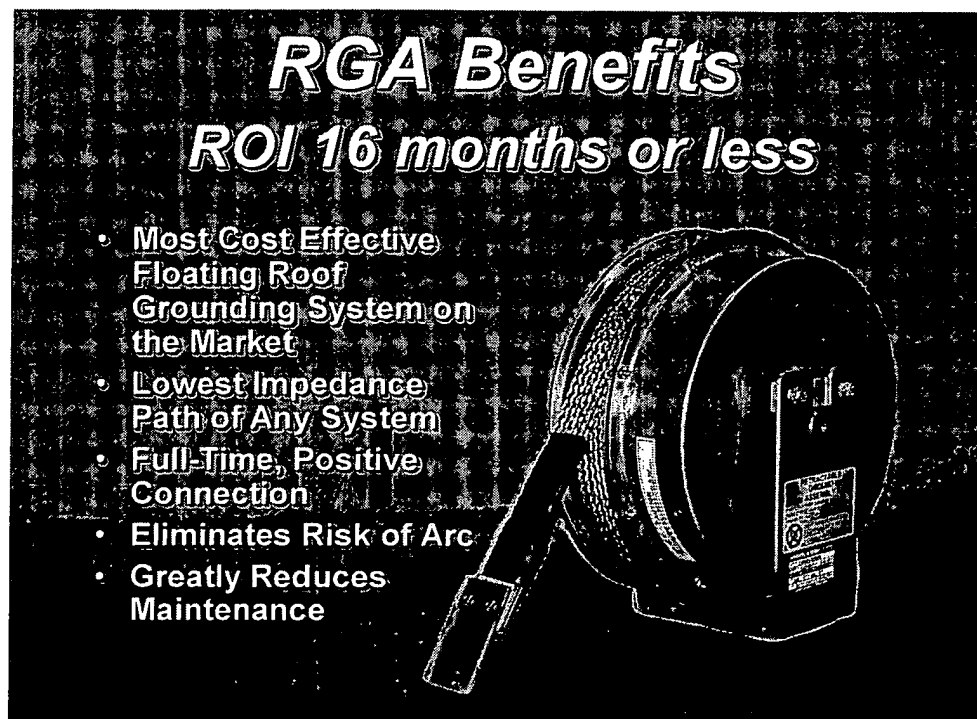
LEC has developed an assembly that will provide a very low-impedance connection to the floating roof grounding and bonding provided in one modest assembly. The LEC Retractable Grounding Assembly (RGA) is 100% effective and is virtually maintenance free. Further, it is independent of the condition of the tank wall and that of any shunts; it also works if no shunts are present. See Figure 10.

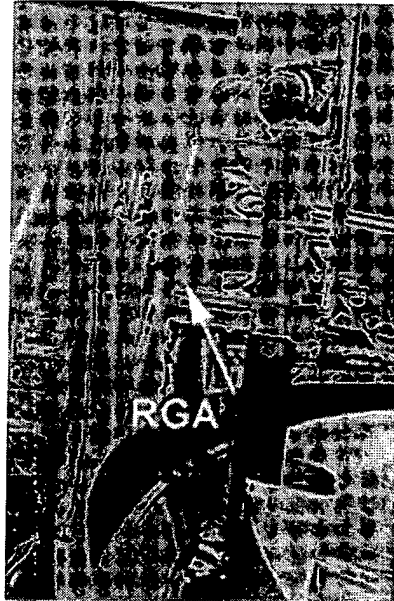
Figure 13 illustrates a typical RGA wall installation as implemented at several tank farms in Israel.
